**DEPARTMENT OF TRANSPORTATION****DIVISION OF ENGINEERING SERVICES**

Contract #: 04-0120F4Cty: SF/Ala Rte: 80 PM: 13.2/13.9File #: 69.28**WELDING INSPECTION REPORT****Resident Engineer:**Siegenthaler, Peter**Address:** 333 Burma Road**City:** Oakland, CA 94607**Report No:** WIR-018686**Date Inspected:** 20-Nov-2010**Project Name:** SAS Superstructure**OSM Arrival Time:** 1900**Prime Contractor:** American Bridge/Fluor Enterprises, a JV**OSM Departure Time:** 700**Contractor:** Zhenhua Port Machinery Company, Ltd (ZPMC), Changxing Island **Location:** Shanghai, China**CWI Name:** See below**CWI Present:** Yes No**Inspected CWI report:** Yes No N/A**Rod Oven in Use:** Yes No N/A**Electrode to specification:** Yes No N/A**Weld Procedures Followed:** Yes No N/A**Qualified Welders:** Yes No N/A**Verified Joint Fit-up:** Yes No N/A**Approved Drawings:** Yes No N/A**Approved WPS:** Yes No N/A**Delayed / Cancelled:** Yes No N/A**Bridge No:** 34-0006**Component:** Tower and OBG Components**Summary of Items Observed:**

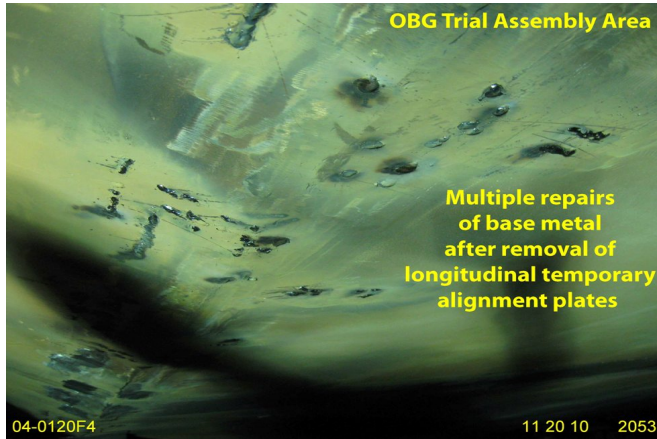
SMAW repair welding of several temporary longitudinal alignment plate welds located outside PCMK OBG 11DE/11EE, side plate to bottom plate, holdback weld area, north (counterweight) side. See photo below. Welder was identified as 040724. QC was identified as ZPMC CWI Shi Lei (QC1). Welding variables recorded by QC1 appeared to comply with WPS-345-SMAW-4G(4F)-FCM-repair-1 as displayed on ZPMC Weld Repair Report B-CWR2139 presented to this QA Inspector and verbally identified by QC1. QC1 also informed this QA Inspector that the above noted repairs were in response to ZPMC visual testing. Also present at this location and appearing to be monitoring the welding operation was ABF Representative Cai Hai Zhou.
